TEST REPORT

Test Report Number: 08F276I
Model Designation: SP 200 & Swift
Portable Piezo Ultrasonic Scaler
Product Description: See Appendix B

Test Report Number 08F276I

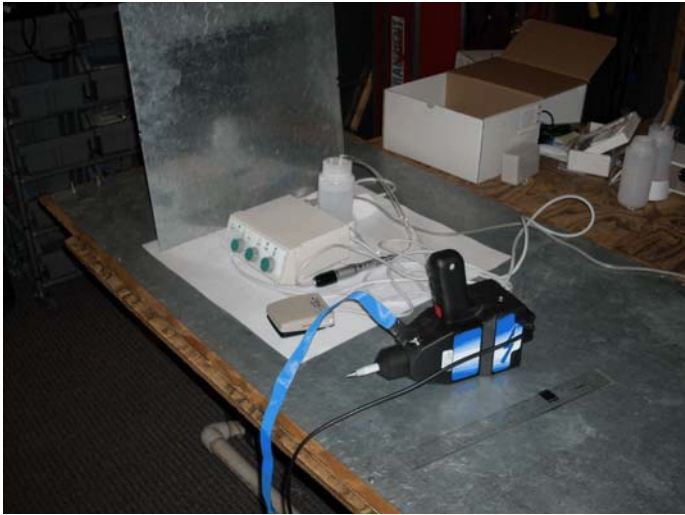
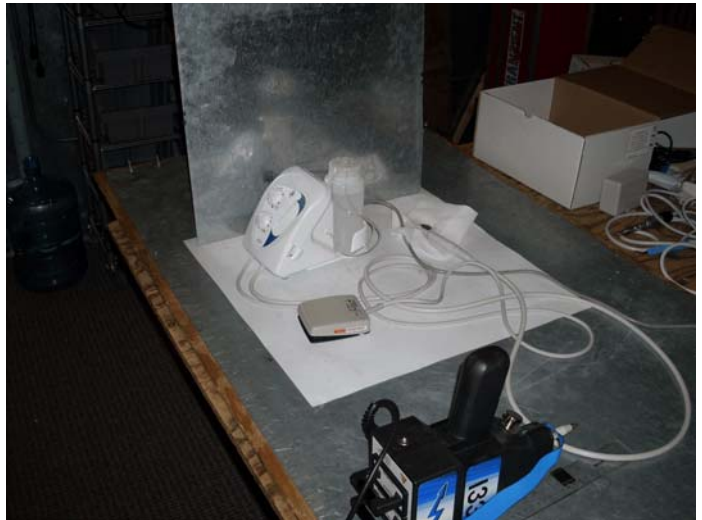
Test-setup photo(s):
Electrostatic Discharge (ESD)
IEC 61000-4-2
EN 61000-4-2

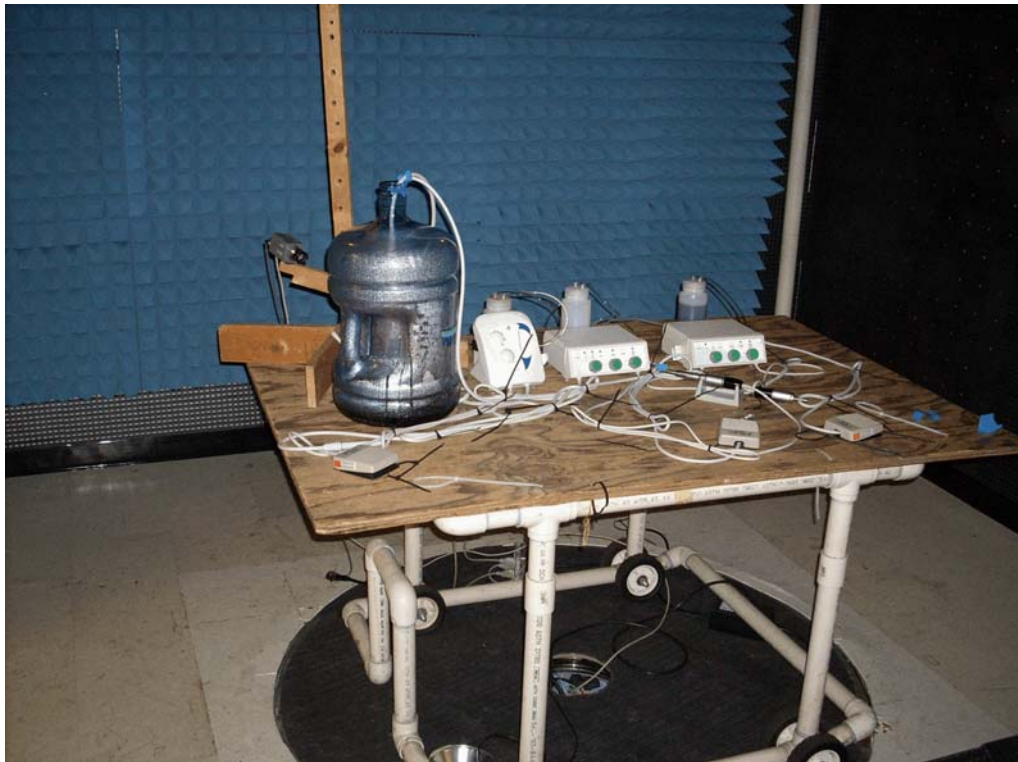
Test-setup photo(s):
Radiated Electromagnetic Field
IEC 61000-4-3
EN 61000-4-3

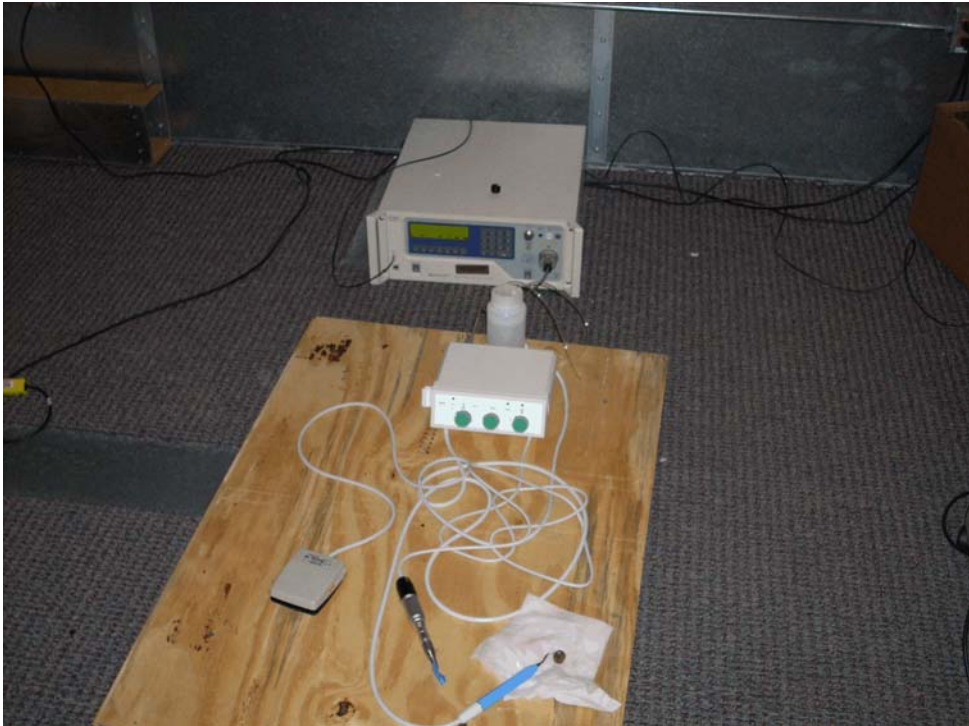
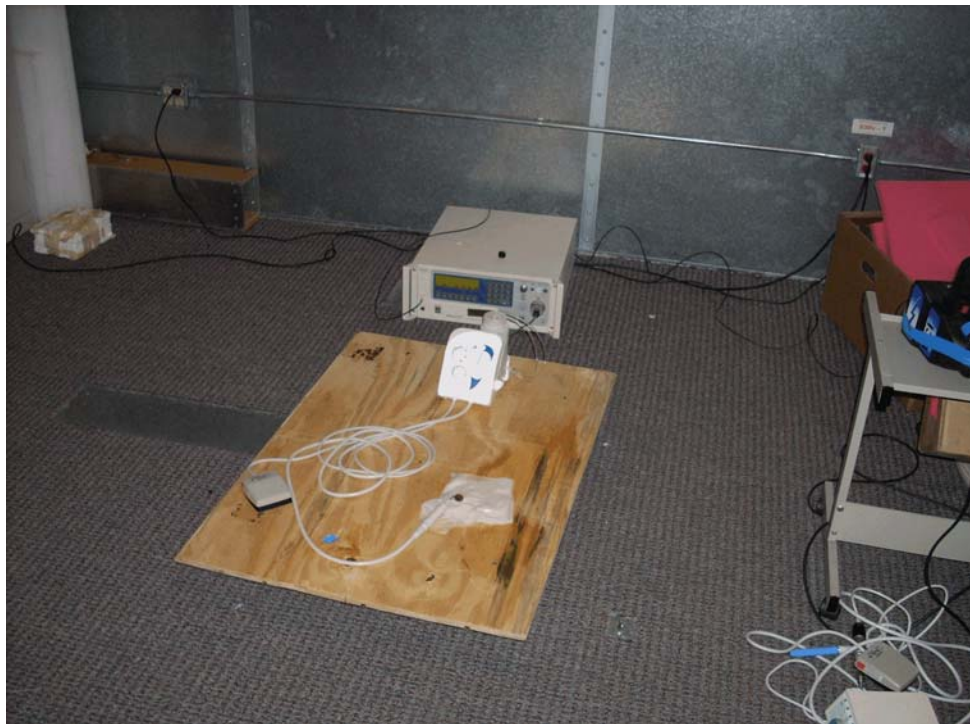
Test-setup photo(s):
Fast transients (BURST)
IEC 61000-4-4
EN 61000-4-4

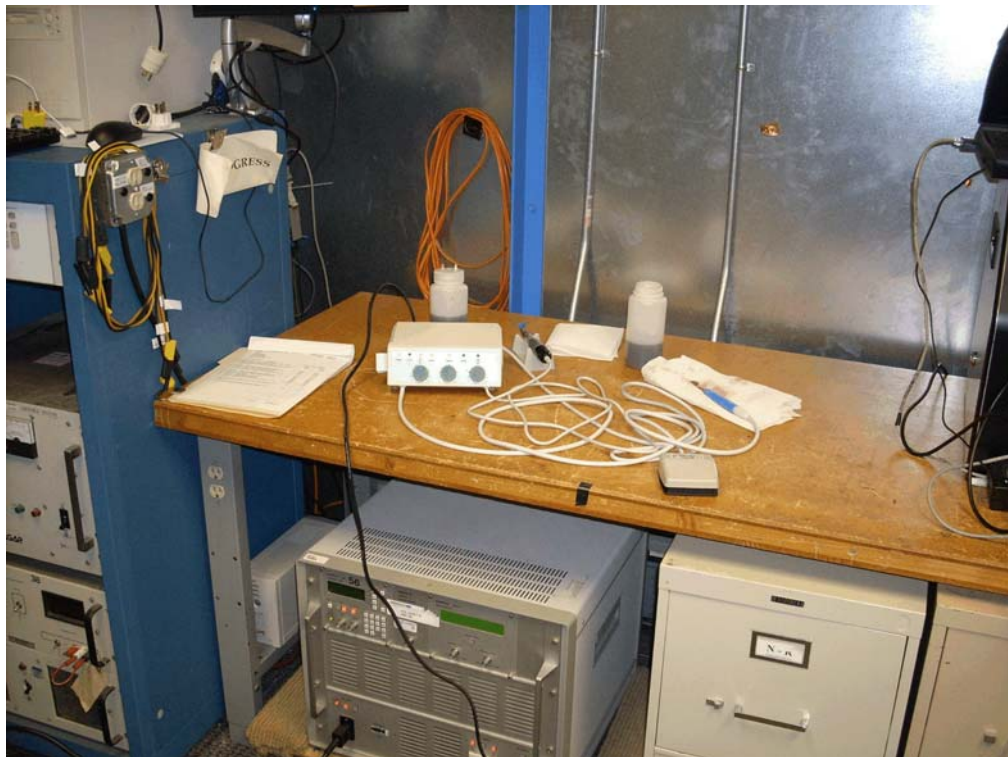
Test-setup photo(s):
SURGE transients
IEC 61000-4-5
EN 61000-4-5

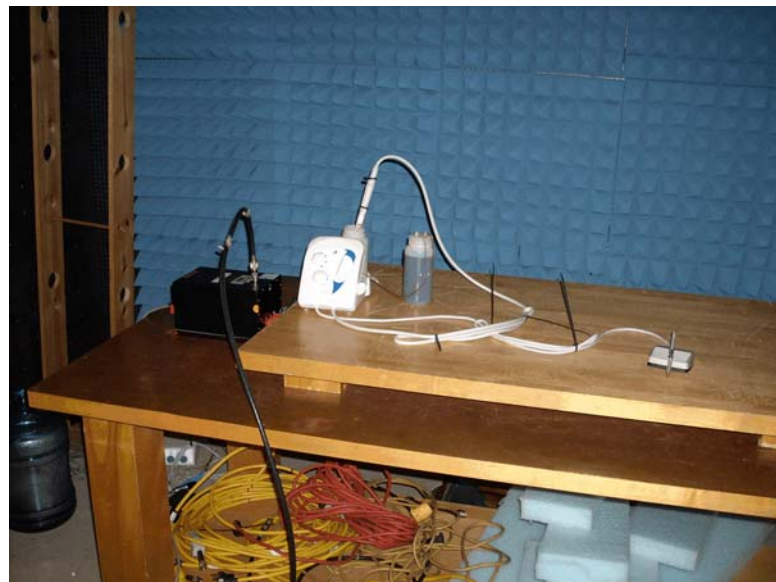
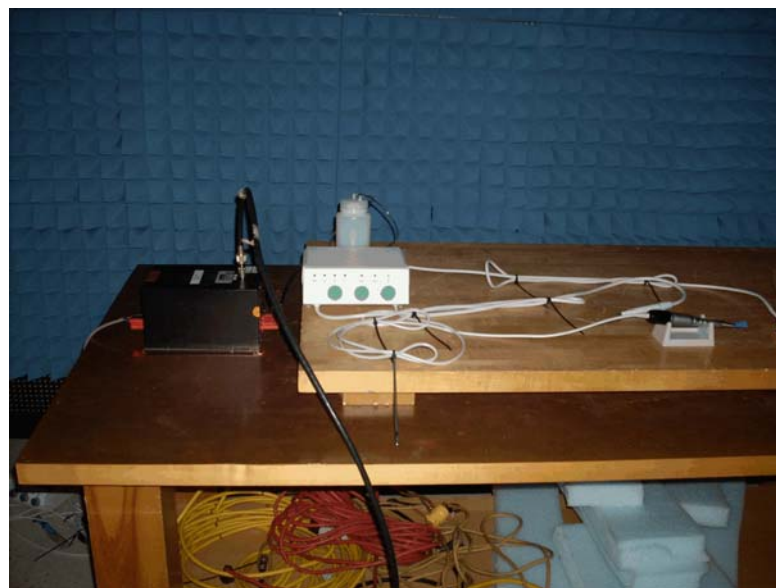
Test-setup photo(s):
Conducted disturbance
IEC 61000-4-6
EN 61000-4-6

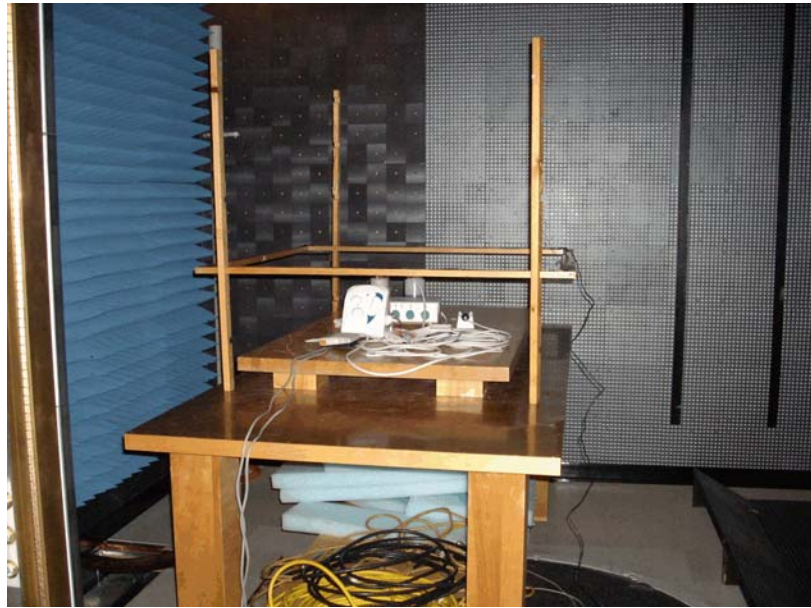
Test-setup photo(s):
Power frequency magnetic field
IEC 61000-4-8
EN 61000-4-8

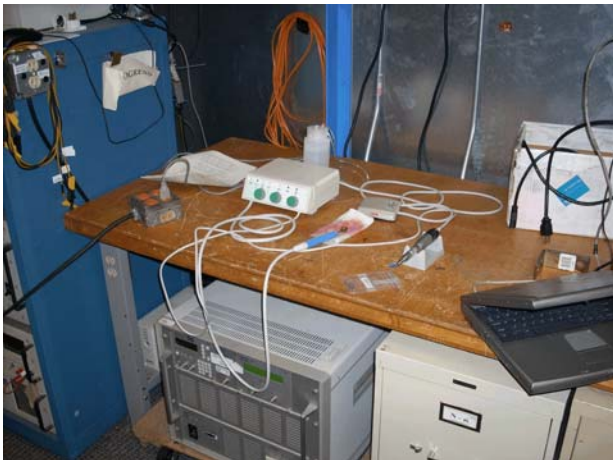
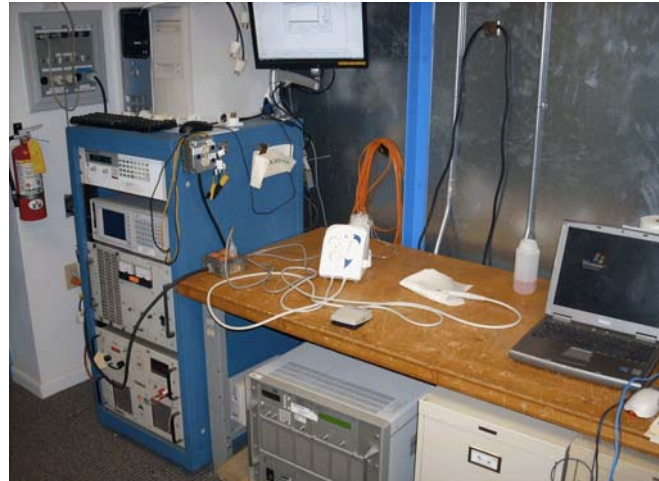
Test-setup photo(s):
Voltage dips, interruptions & variations
IEC 61000-4-11
EN 61000-4-11

Setup photo unavailable
- setup is similar to voltage dip test
